# RUNWAY 13/31 FRICTION RESTORATION

**We are pleased to announce that the friction issues associated with the overlay on Runway 13/31 have been resolved.**

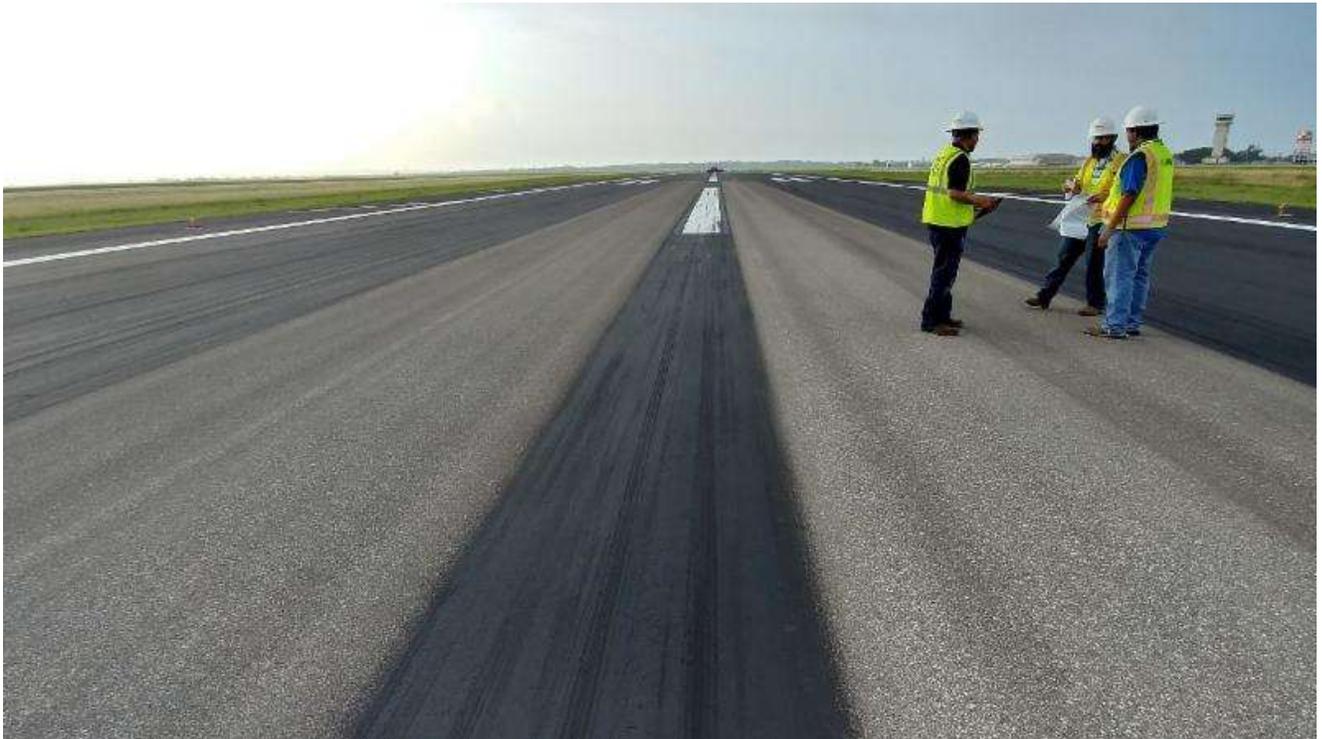
Upon reports of diminished braking action on Runway 13/31 when the surface was wet, Airport Management and the City of San Marcos began working closely with TxDOT Aviation and the engineering firm for the project to determine a solution.

In an effort to resolve the loss of surface friction, TxDOT proposed a shotblasting technique to abrade the surface which had been successfully performed at other airports and on highway surfaces.

A shotblasting contractor, Skidabrader, mobilized to the airport on Tuesday morning to abrade a test area. This area was used to support making a decision to complete the entire runway to improve friction sufficiently to the point that aircraft can land safely in wet weather.

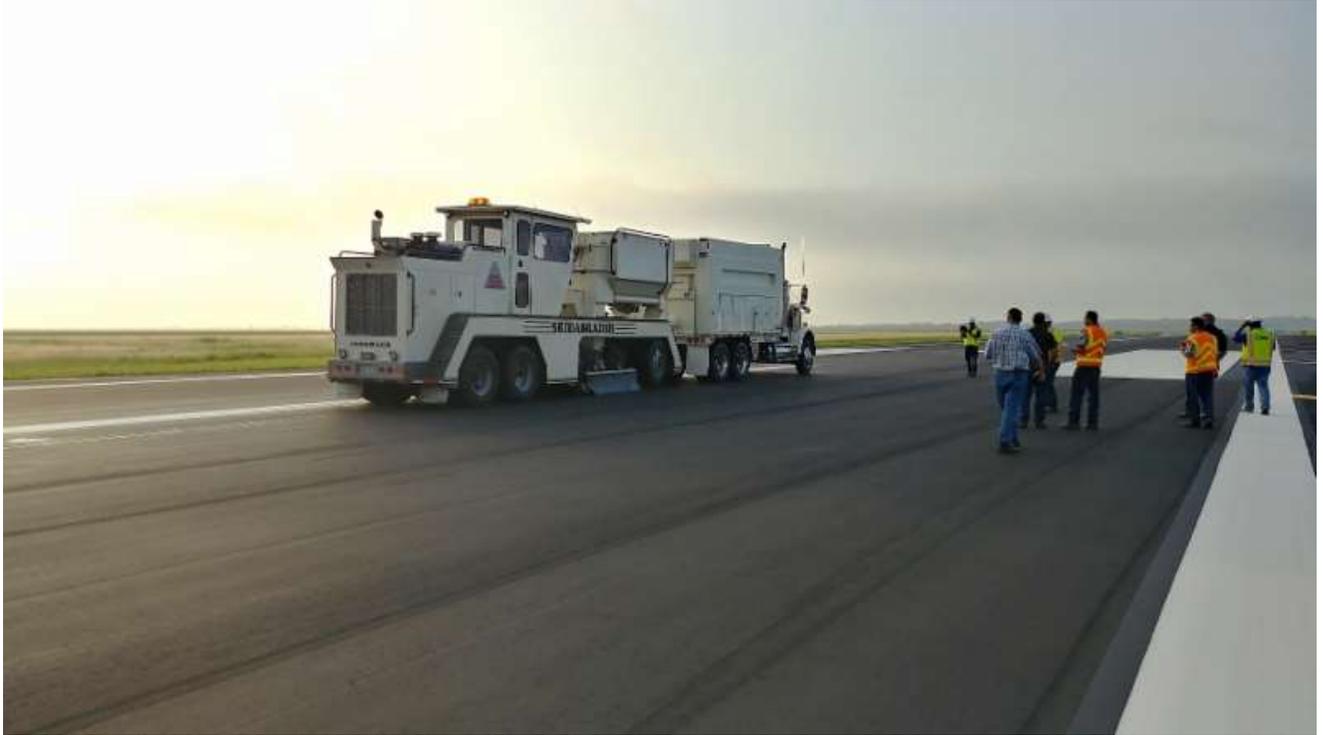
After the test area was abraded, several tests were performed which indicated a significant improvement in friction.

To confirm the test results, McCoy's Building Supply volunteered to accelerate to approximately 90 knots in their Cessna Citation and apply their brakes over the abraded surface and continue onto the original surface. The pilot reported excellent braking action on the abraded surface compared to significantly diminished braking action on the original surface.

As a result of these engineering and pilot tests, Skidabradar was given the green light to complete the shotblasting technique on the entire length of the runway.
