# GripTester: Measuring Airport Runway Friction Levels Before and After Shotblasting for Retexturing

## San Antonio International Airport Project

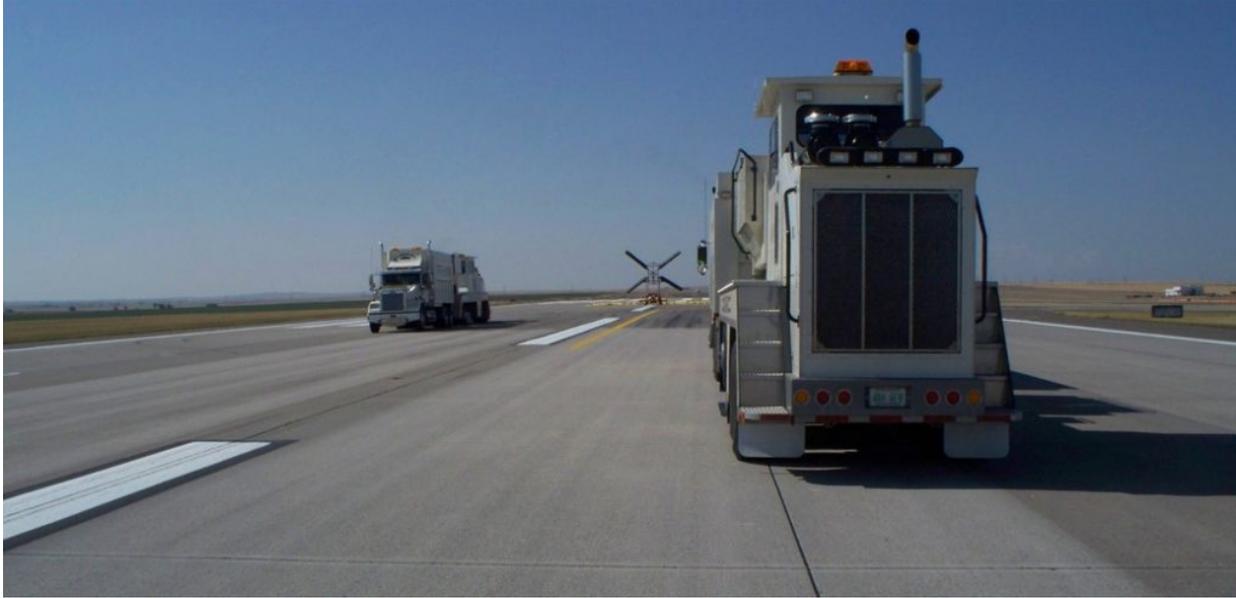
Shotblasting is a mechanical process where a volume of steel pellets—or shot—is propelled with high velocity onto a concrete or asphalt surface. The shot impacting on the pavement abrades the surface, removing contaminants such as rubber deposits, and creates additional texture, that, in turn, improves friction. The main benefit of shotblasting is that it is environmentally friendly. The steel media used is contained and recycled within the system. The removed material is captured within a containment system where it can be disposed of at a proper site. Shotblasting can increase both the macro and microtexture of the pavement surface, where other methods typically affect only the macrotexture. Increased macrotexture allows for better evacuation of water beneath aircraft tires, and better microtexture improves contact between the tire and pavement surface, increasing the friction level.

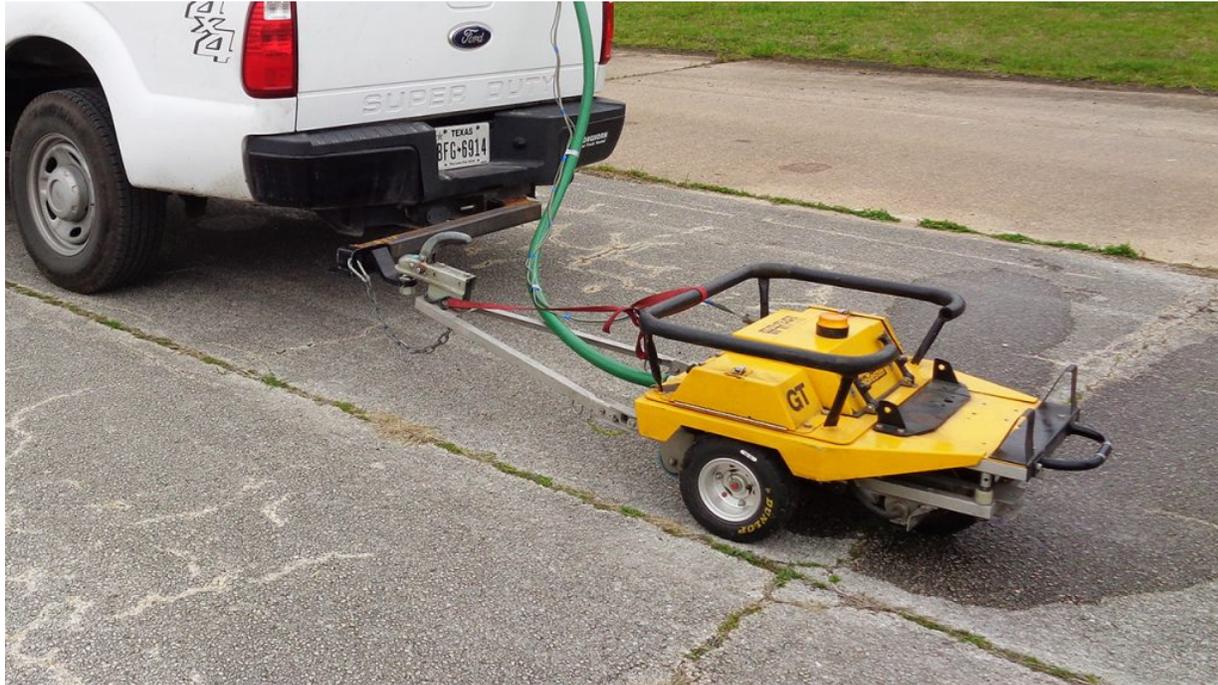
The GripTester is a fixed-slip continuous friction measuring device that provides a friction reading (GripNumber) approximately every three feet over the surface tested. It is a towed device and

measures friction at about a 14% slip rate. This means the test tire is rotating 14% slower than a free-rolling tire, generating a drag force that is used to quantify friction.

Because wet pavement has lower friction than dry pavement and is considered a worst case, the GripTester contains a self-wetting system which applies a 1 mm (0.04 inch) depth water film just in front of the test tire. For runways, the typical test procedure is to measure friction at speeds of 40 and 60 mph and at 10 and 20 feet on each side of the runway centerline. Results are reported in 500-foot intervals.

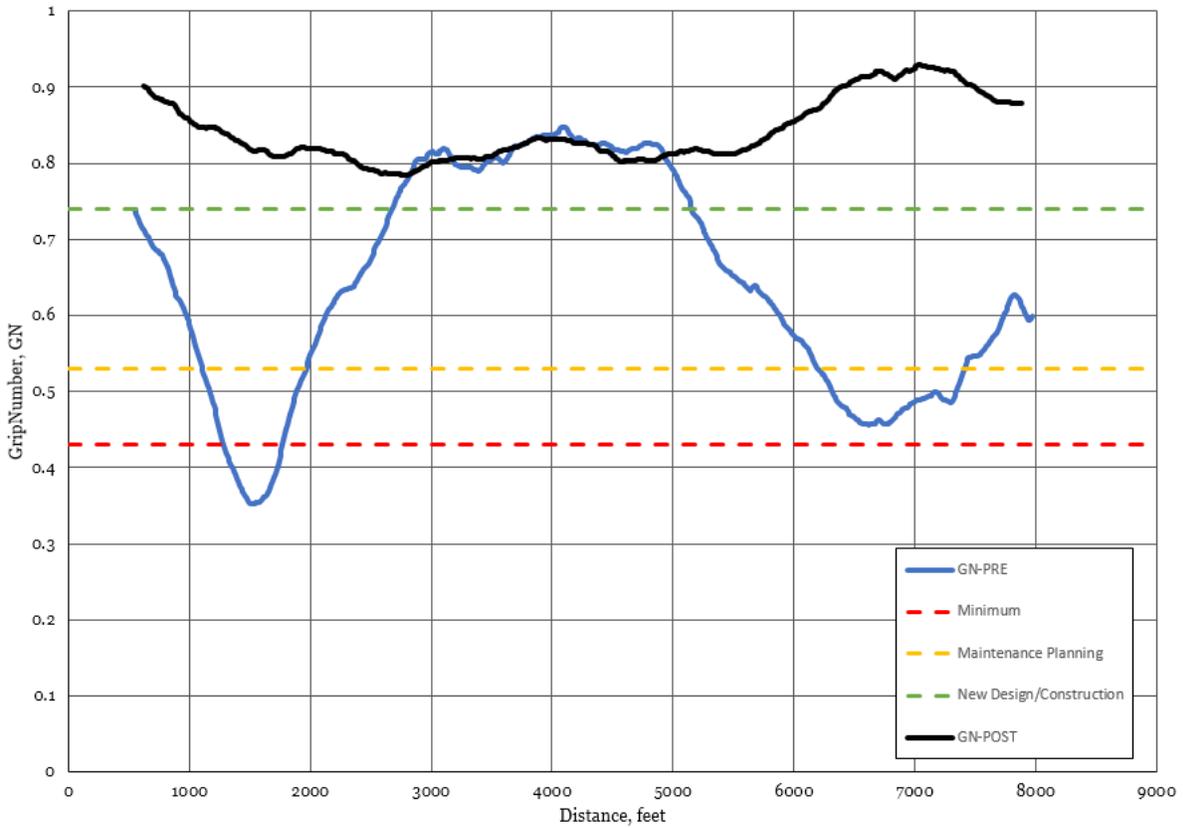
# Runway 31L

The graph illustrates pre- and post-shotblast friction results on Runway 31L. Post-shotblast friction levels (represented by the solid black line) exceed FAA required minimum levels for new design/construction (represented by the dashed green line).

Friction testing was conducted on the runway prior to shotblasting and again the day after the completion of shotblasting. GripTester runs were conducted in both directions, 10 feet to the right of the runway centerline, and at a speed of 40 mph. The data collection began and ended at the first touchdown zone markings, ensuring data was captured over the areas with the most severe rubber buildup.

Transtec's friction testing confirmed that Skidabrader's shotblasting treatment successfully restored friction not only above maintenance/planning levels, but also above the required friction levels for new construction.

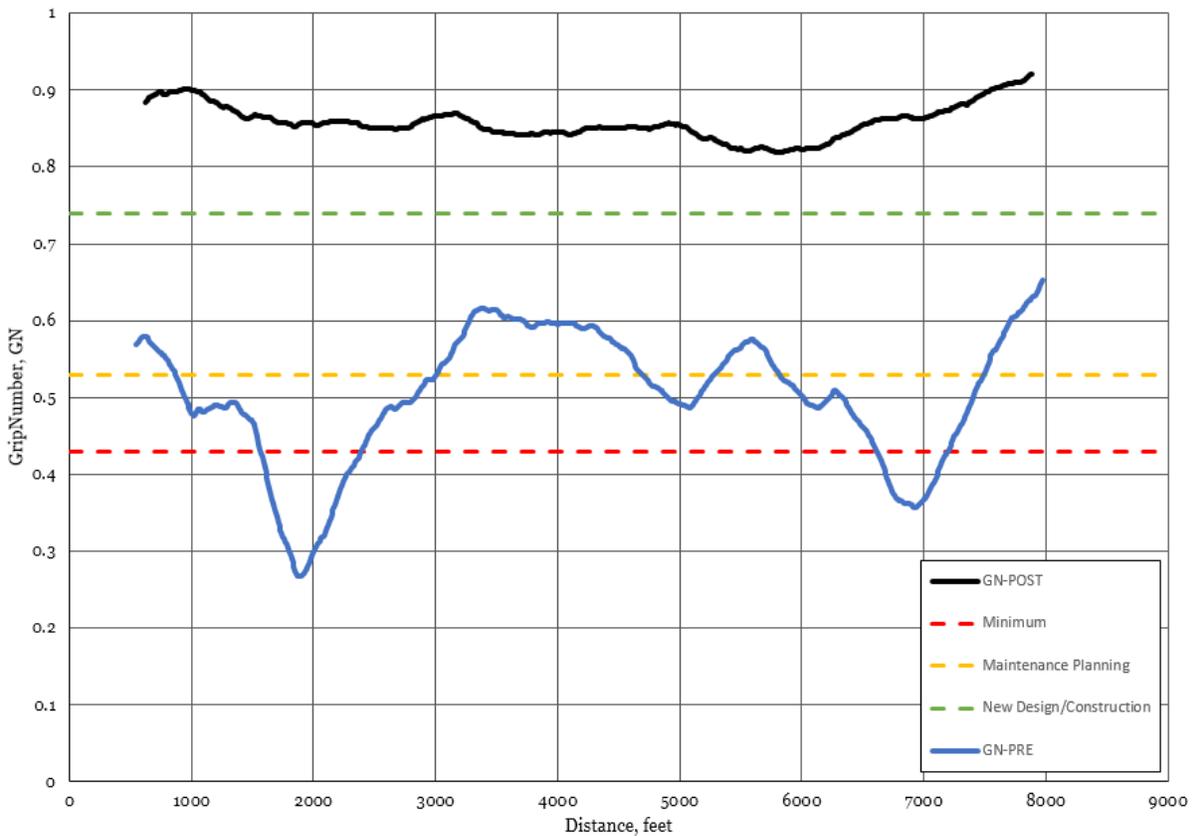
## Runway 13R

The graph illustrates pre- and post-shotblast friction results on Runway 13R. Post-shotblast friction levels (represented by the solid black line) exceed FAA required minimum levels for new design/construction (represented by the dashed green line).
