**ITC Blastrac trial**

retexturing porous asphalt by steel shot blasting

Date	21 August 2013
Status	final

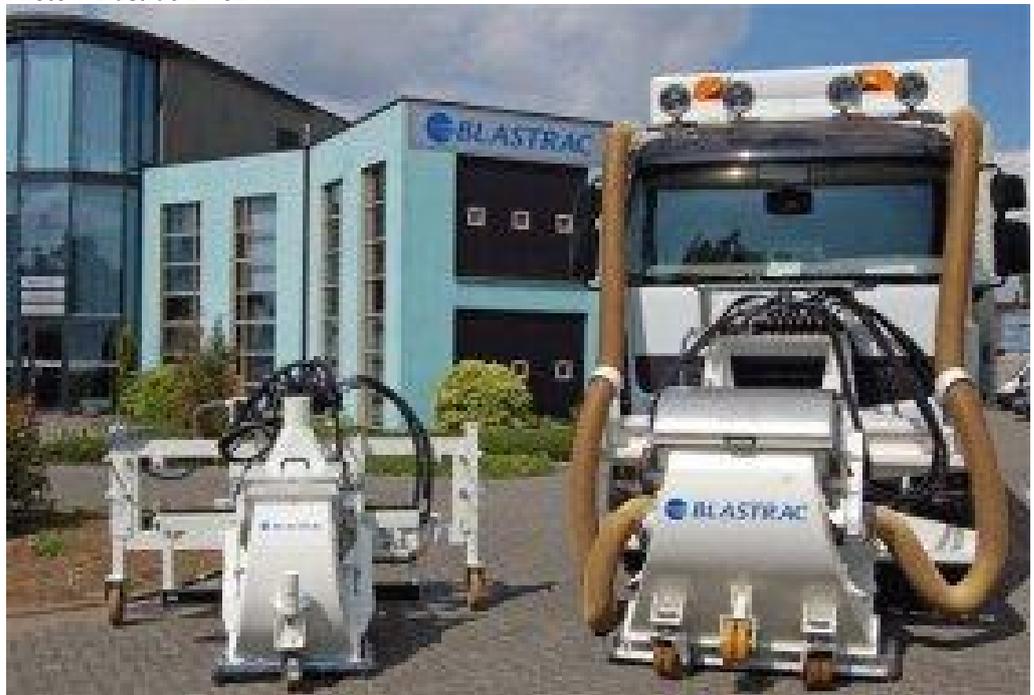
**Photo 1 Blastrac 2-45DTM**

The system tested was a Blastrac 2-45DTM (see Photo 1). The system consists of a shot blaster unit mounted on the front of a lorry. The blaster unit is connected to the lorry by four hydraulic and one electrical connection. Two air hoses are used to carry away the surface material removed. A magnet in the blaster housing recovers the steel shot from the surface material enabling it to be reused. Operation is from the driver's cab.

The maximum width that can be treated in a single pass is 1150 mm. The blaster unit weighs 1750 kg. It can be adjusted in width so as to treat the whole width of a lane. Operating speed can be varied between 0.5 and 40 m/min.

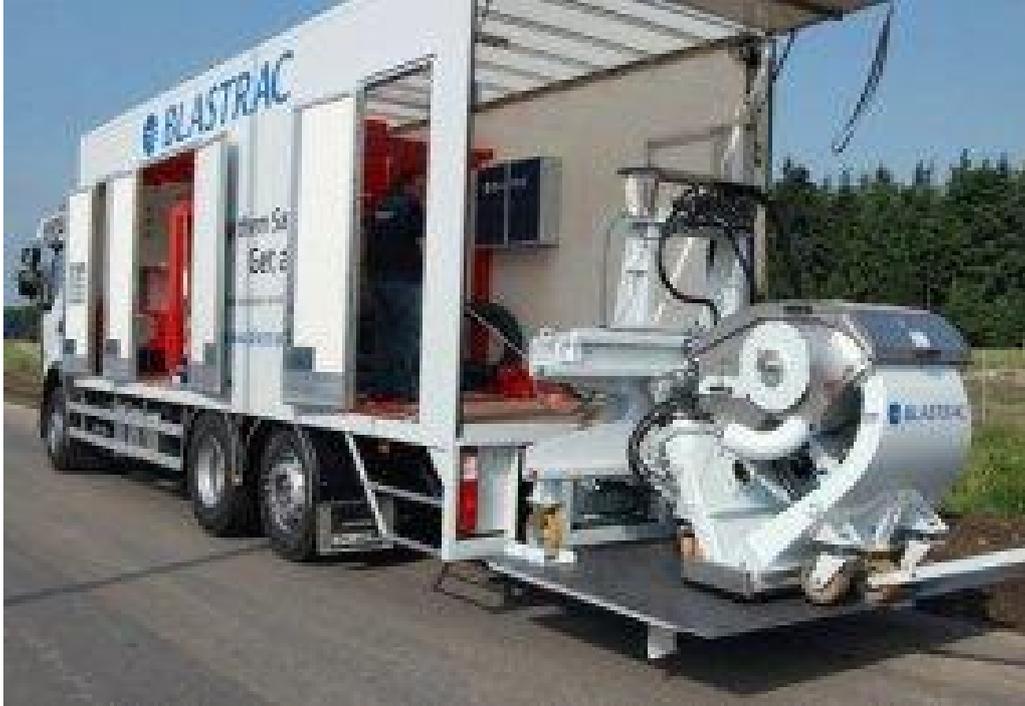
**Photo 2 Blasting unit in rear of lorry**

Between jobs the blaster unit can be removed for transport in the rear of the lorry. See Photo 2.

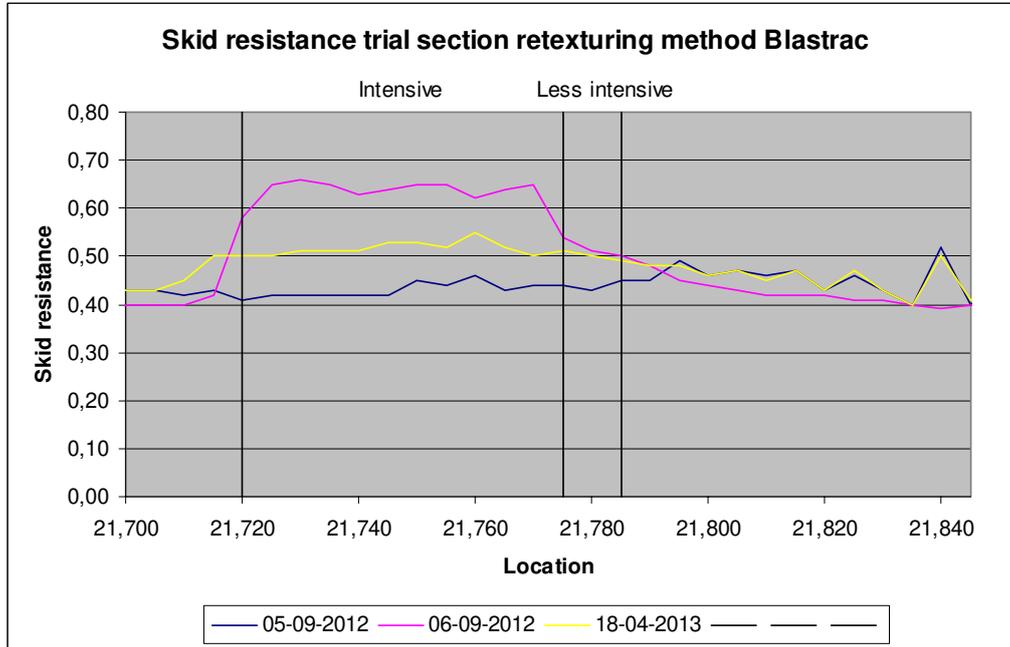
Figure 1 Skid resistance

The changes are also shown in Figure 1. The blue line shows the level of skid resistance before the treatment, the purple line the level immediately after the treatment. The improvement is plain to see. The yellow line shows skid resistance after six months; it will be seen that by that time skid resistance was about the same on both the treated sections.

Six months later, skid resistance on the intensively treated section had declined by between 0.07 and 0.15 compared with immediately after the treatment. Despite this sometimes sharp drop, there was still a clear residual effect. On the less intensively treated trial section the decline was much less at only 0.01-0.03. Here again there was a clear residual effect. At the time of writing, skid resistance is about the same on both treated sections.

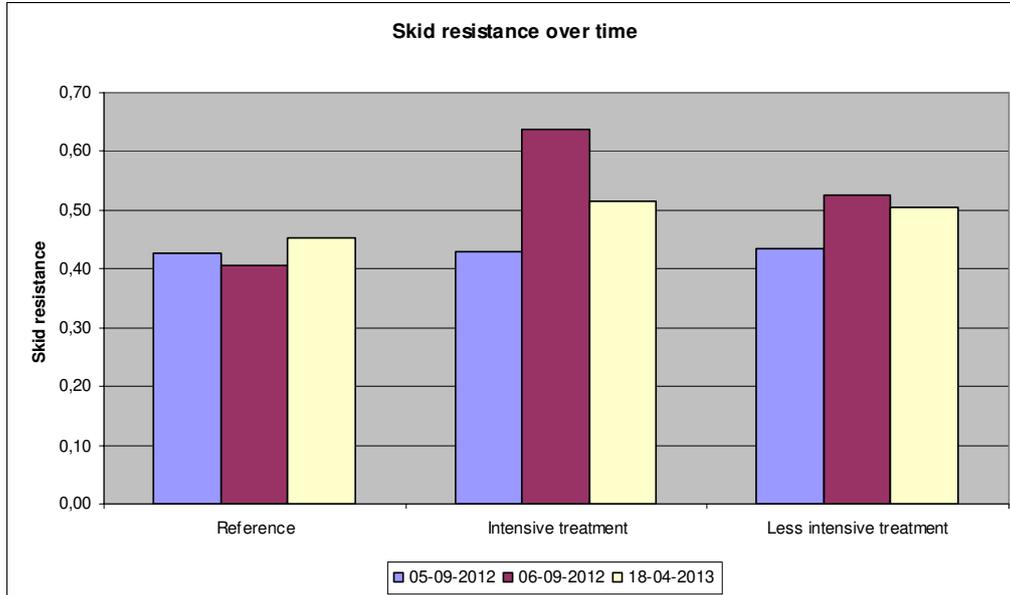
Figure 2 Skid resistance over time for each trial section

Figure 2 shows the changes over time for each trial section. It will be seen that skid resistance remains broadly unchanged on the reference section whereas on the section receiving the more intensive treatment there is a sharp increase in skid resistance followed by a decline. On the less intensively treated section skid resistance increases and thereafter remains steady.
